CCS Technical Documentation
NPD-1 Series Transceivers

Troubleshooting – Antenna

Issue 1 11/2002 Confidential
©Nokia Corporation

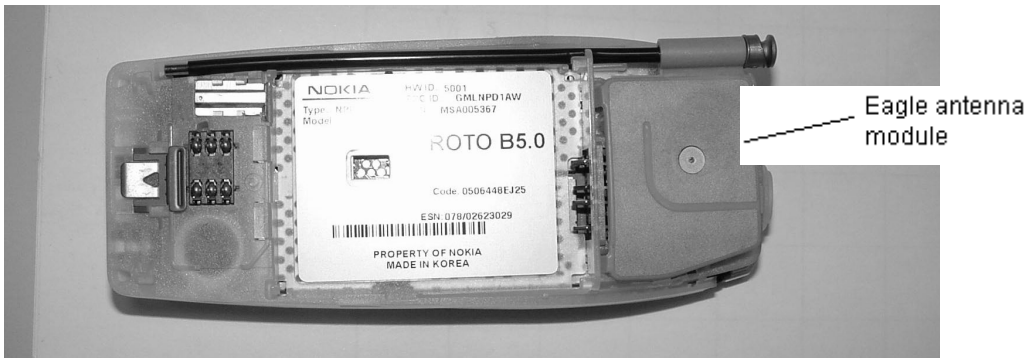
Figure 1: Eagle Antenna Module installed)

A properly installed and plated Eagle antenna module is shown in Figure 1.

If no internal antenna is installed, the antenna gain will be degraded by more than 25 dB.

If the Eagle antenna module is missing, install one. If an unplated internal antenna is installed, replace it with a properly plated internal antenna module.

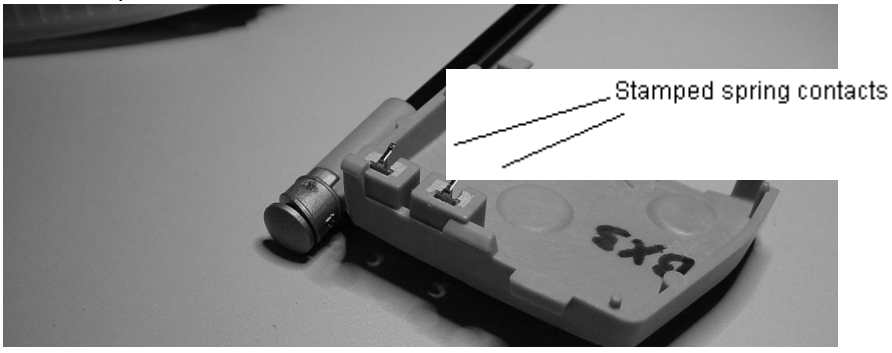
Figure 2: RF feed and ground stamped contact spring clips properly installed

Figure 2 shows the RF feed and ground stamped contact spring clips properly installed. Figure 3 shows both stamped contacts spring clips missing. If the either contact is missing or bent, replace antenna module with new antenna.

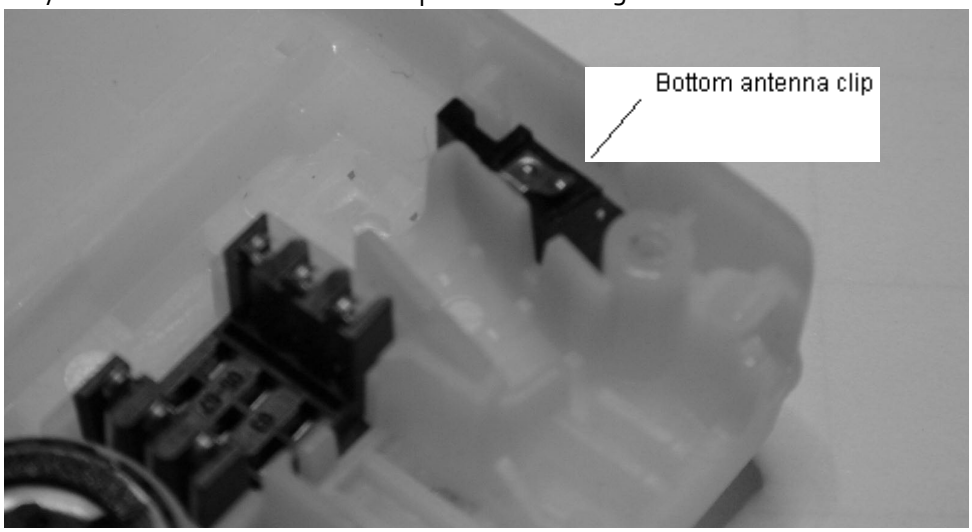
Figure 4: Properly installed bottom antenna clip

The bottom antenna clip is located near the bottom of the phone in the D-cover. A properly installed bottom antenna clip is shown in Figure 4.

The degradation in antenna performance is only about 2 to 4 dB in the receive portion of the CELL band when the whip is retracted. PCS band, retracted whip, degradation will be 10 to 15 db.

If the bottom antenna clip is bent or missing, then it should be carefully replaced with a new one.

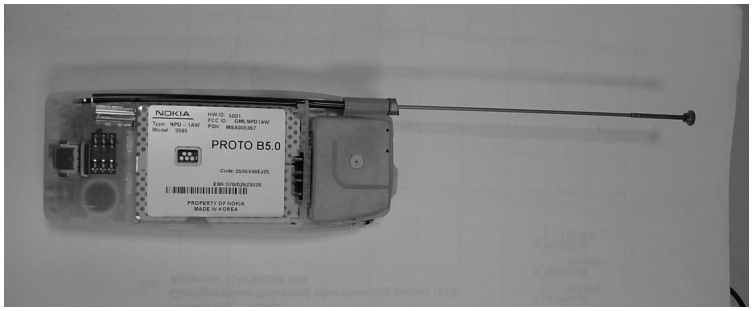
Figure 5: Properly installed whip antenna

The whip will perform 2 dB better than the internal antenna in free space. The whip will perform up to 3 dB better than the internal antenna in talk position.

If the whip is missing, then the Eagle antenna module should be replaced. Figure 5 shows a properly installed whip antenna.

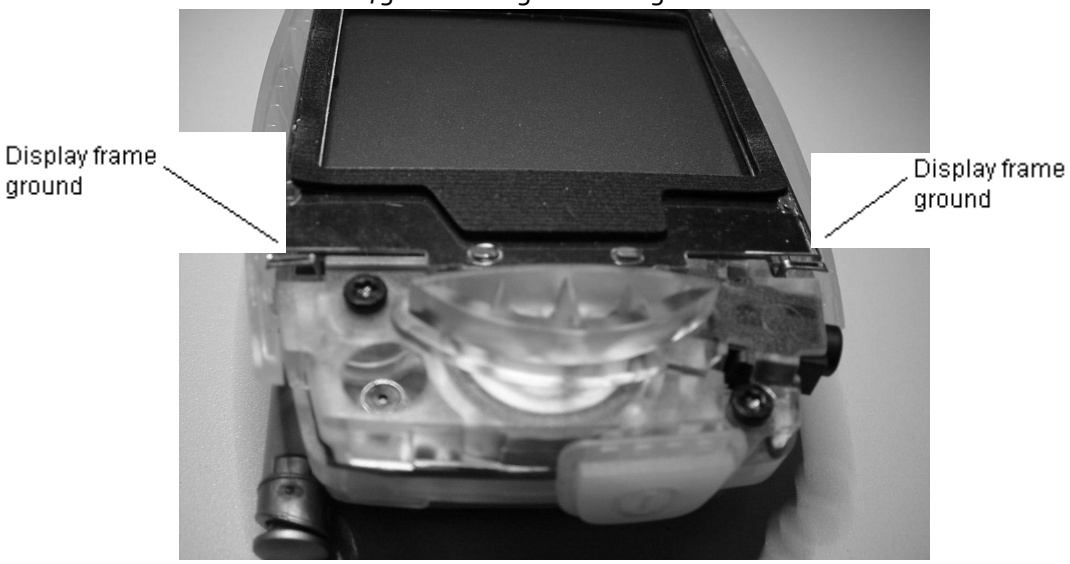
Figure 6: Display frame grounded by two spring clips

The display frame is normally grounded by two spring clips (Figures 6). The figure shows the display frame grounding locations. If clips are missing or bent, replace light guide with good one. SAR performance will degrade by .5 mW/g for one leg not grounding to the PWB to over 1.7mW/g if both legs are not grounded.

The D cover and light guide have snaps near the display frame ground positions. Make sure they are locked in position for ESD protection. These snap features help maintain display leg contact with the PWB.
